**CARACTERIZAÇÃO CONSTRUTIVA E MECÂNICA
DE PAREDES DE ALVENARIA DE ADOBE DE
EDIFÍCIOS EXISTENTES**

**CONSTRUCTIVE AND MECHANICAL
CHARACTERISATION OF ADOBE MASONRY
WALLS OF EXISTING BUILDINGS**

Tese apresentada à Universidade de Aveiro para cumprimento dos requisitos necessários à obtenção do grau de Doutor em Engenharia Civil, realizada sob a orientação científica do Prof. Doutor Aníbal Guimarães da Costa, Professor Catedrático do Departamento de Engenharia Civil da Universidade de Aveiro, e coorientação do Prof. Doutor Humberto Salazar Amorim Varum, Professor Catedrático do Departamento de Engenharia Civil da Faculdade de Engenharia da Universidade do Porto.

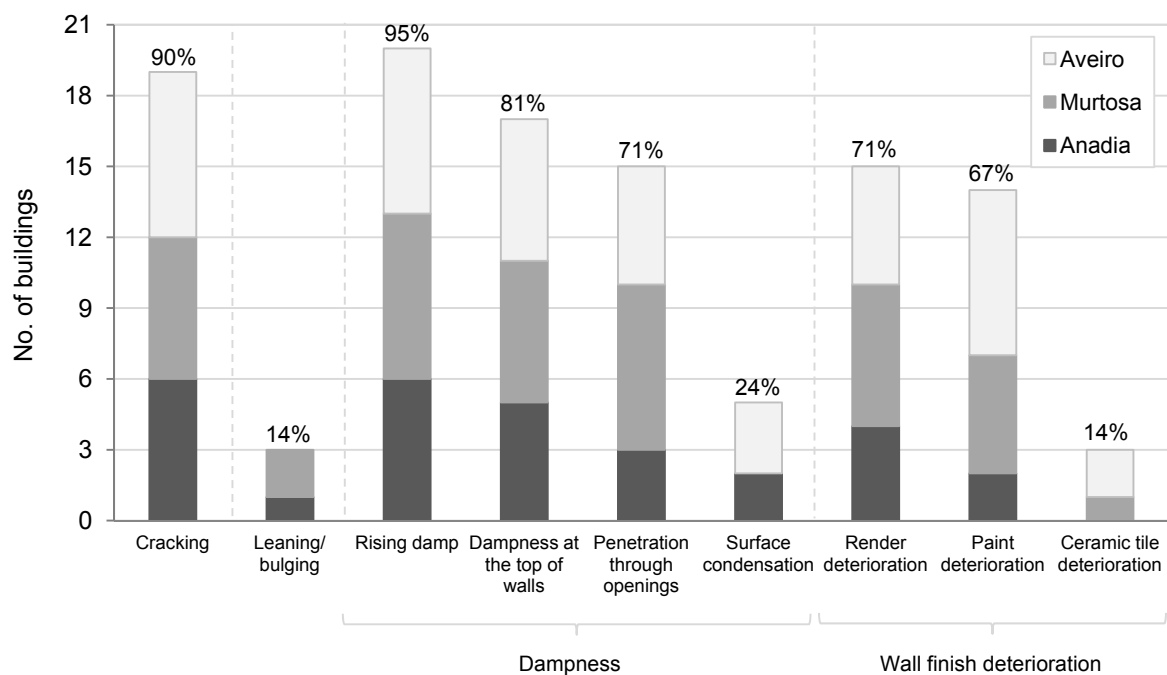
The most common defects observed in the facade walls of the buildings studied are presented in Figure 2.11. The number and percentage of buildings, per municipality, that present each defect are also indicated. The most common defects observed and their possible causes are described below.

Figure 2.11: Common defects observed in facade walls.

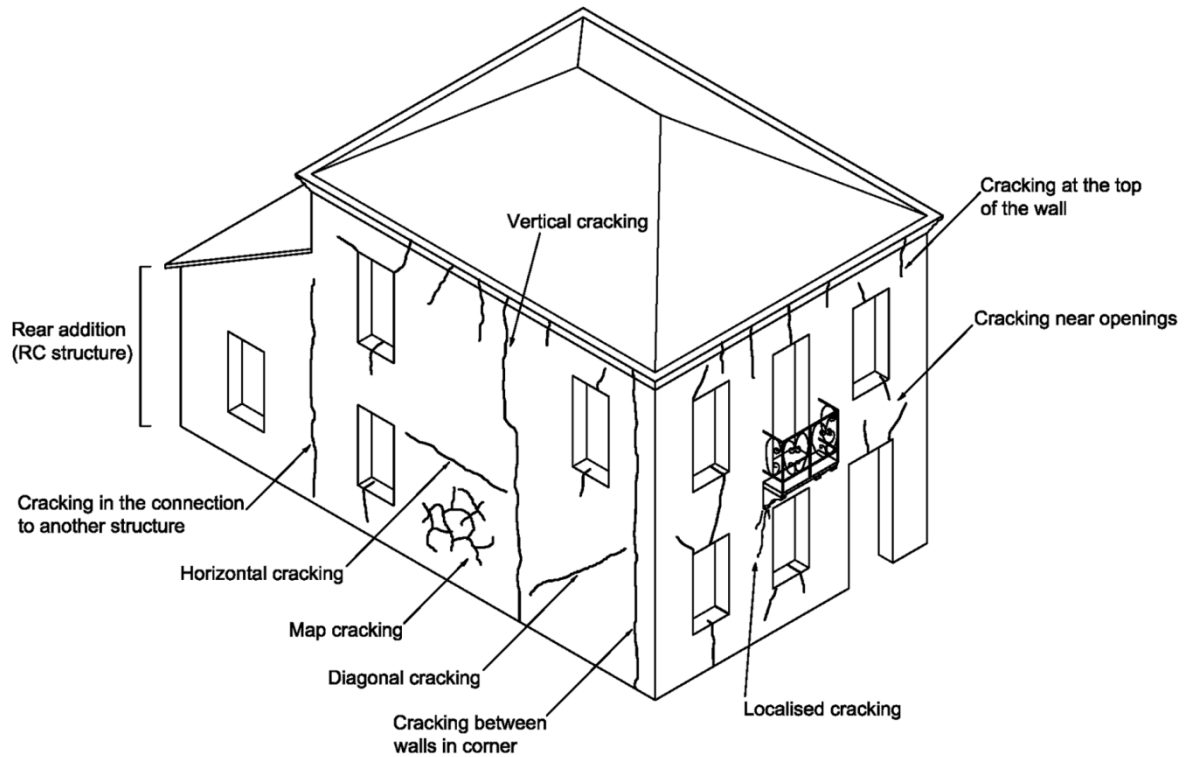
Figure 2.12: Schematic representation of the types of cracking observed in facade walls.

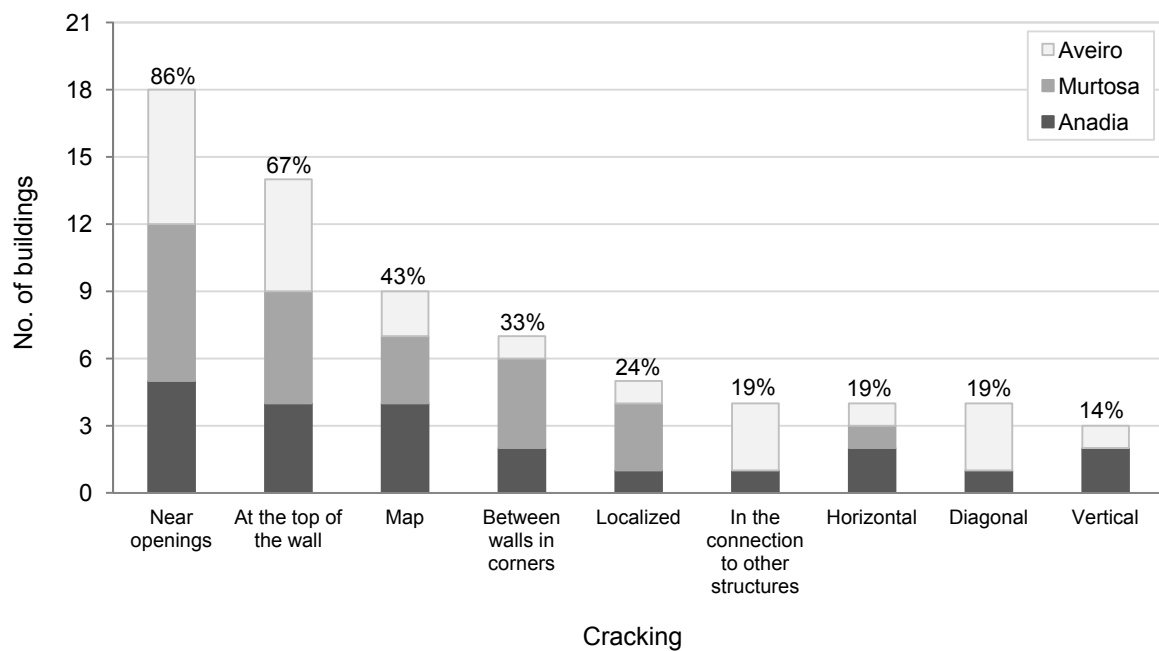
Figure 2.13: Types of cracking observed in facade walls.

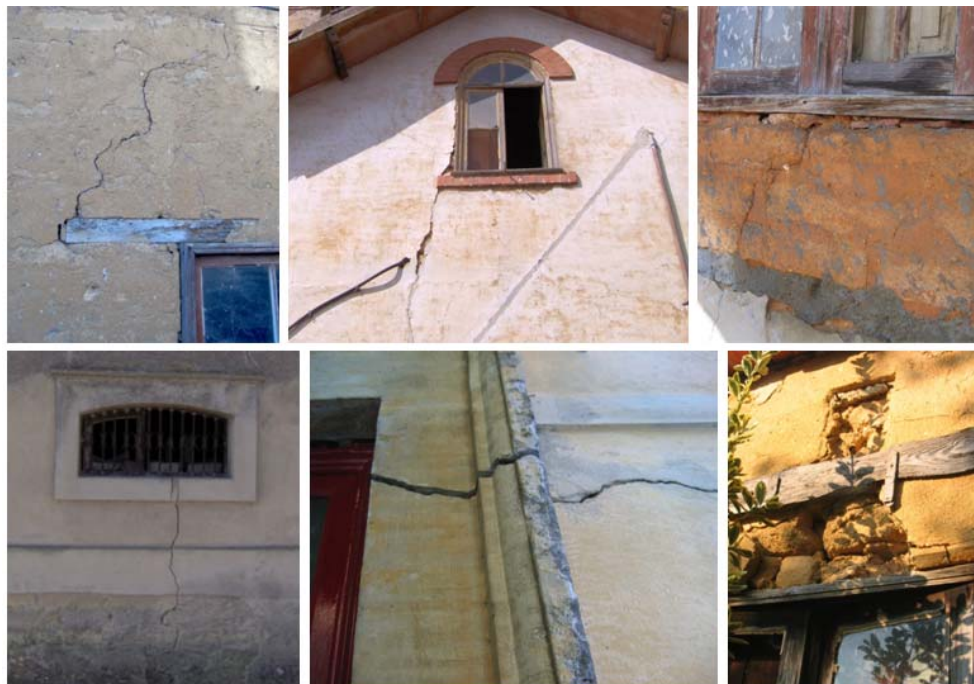
The cracks near openings observed in the buildings studied are mainly located above or below the openings, frequently near the corners, and generally have vertical or diagonal orientation (Figures 2.12 and 2.14). In some cases, cracking is thin and superficial, affecting only the render layer; more frequently, however, it is thick and deep, affecting also the support structure. In one building ('H21'), intense cracking led to the partial disintegration of masonry above two openings (Figure 2.14). Common causes for cracking near openings are: excessive load (Thomaz 2003), generally imposed by the roof or floor structures; insufficient support of the masonry above the openings; stress concentration in the corners; and excessive percentage of wall area with openings. In some of the cases observed, differential foundation settlement is also a possible cause for the existing cracking (Richardson 2001; Thomaz 2003).

Figure 2.14: Cracking near openings.

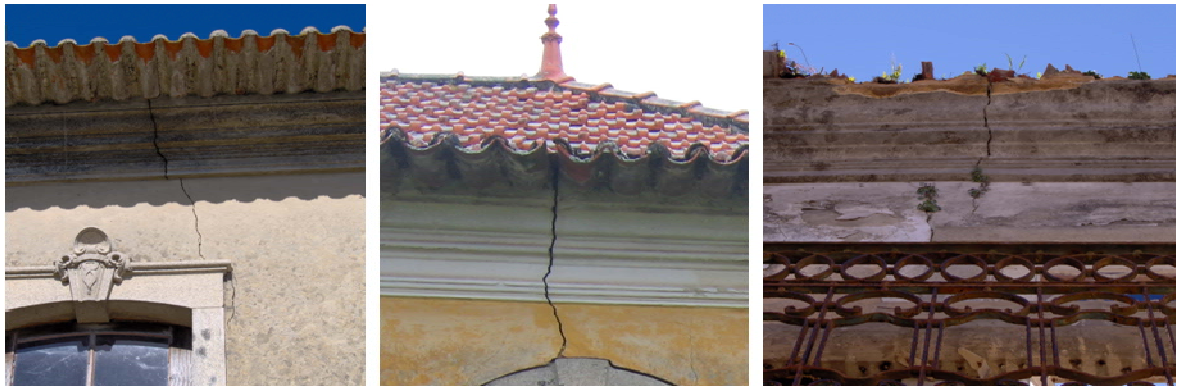
superficial, but in other cases the cracks are thick and affect the support structure. This type of cracking is generally caused by excessive load or deformation imposed by the roof structure (Thomaz 2003).

Figure 2.15: Cracking at the top of walls.

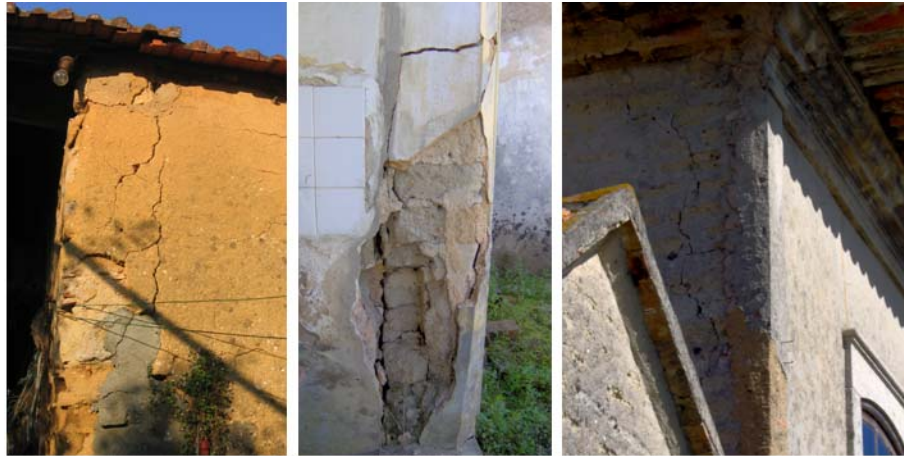
Structural cracking between perpendicular facade walls, in corners, was observed in some of the buildings under study (Figures 2.12 and 2.16). This type of cracking is generally vertical, following along the area of connection between walls. In some of the cases observed, vertical cracking is combined with diagonal or scattered cracking along the corner. Possible causes for this type of cracking are: deformation of the walls due to variations in temperature or moisture content (Thomaz 2003); differential foundation settlement (Pagaimo 2004); and horizontal thrust imposed by the roof which leads to the rotation of one or both perpendicular walls (Pagaimo 2004). These factors can lead to cracking or even separation between facade walls, especially when combined with a weak connection between walls.

Figure 2.16: Cracking between perpendicular walls in corners.

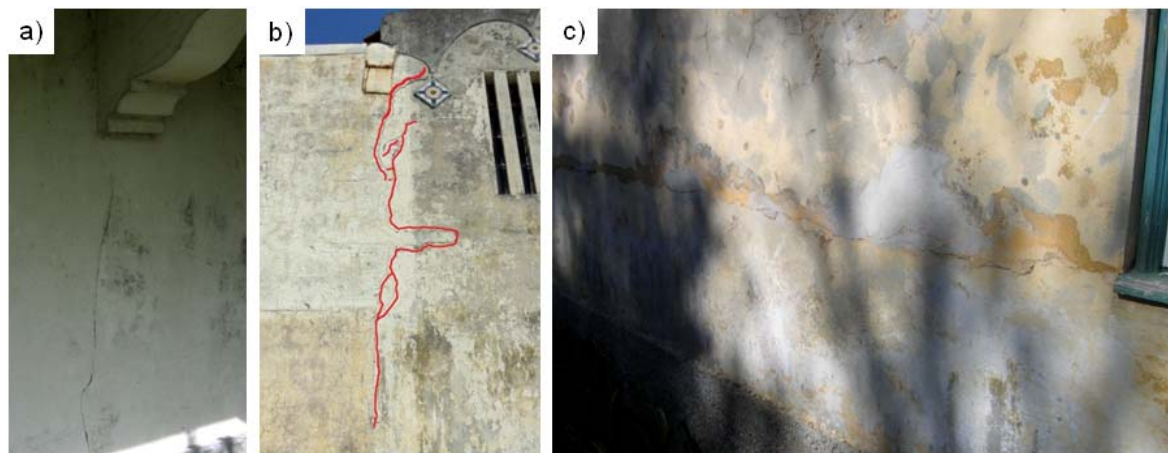
Localised cracking in the facade walls, due to stress concentration, was observed near the points of support of balconies (Figures 2.12 and 2.17a), steel rods, and beams. This type of cracking is generally thick, affecting the support structure. The cracks are vertical or diagonal and are sometimes combined with crushing around the support points.

Figure 2.17: a) Localised cracking near the support of balcony; b) cracking in the connection to rear addition; c) long horizontal cracking.

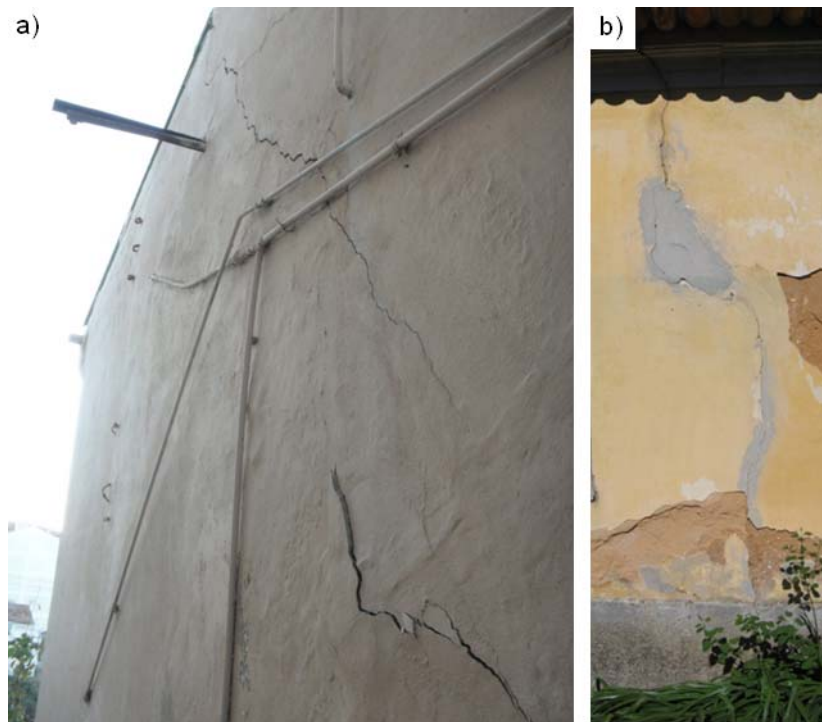
Long diagonal cracking was also observed in the facade walls of some of the buildings studied (Figures 2.12 and 2.18a). In all cases, the cracks are thick and appear to affect the support structure. In building 'H39', one diagonal crack is located near an opening, extending diagonally and downward towards a corner of the building, and seems to be caused by excessive load imposed by the roof structure. In the other cases where this type of cracking is observed, cracks appear to be caused by differential foundation settlement – in these cases, the diagonal cracks lean towards the point where the largest settlement occurred (Richardson 2001; Thomaz 2003). In building 'H39', one diagonal crack of this type is particularly severe, compromising the structural stability of the building (Figure 2.18a).

Figure 2.18: a) Diagonal cracking; b) vertical cracking in the central area of the wall.

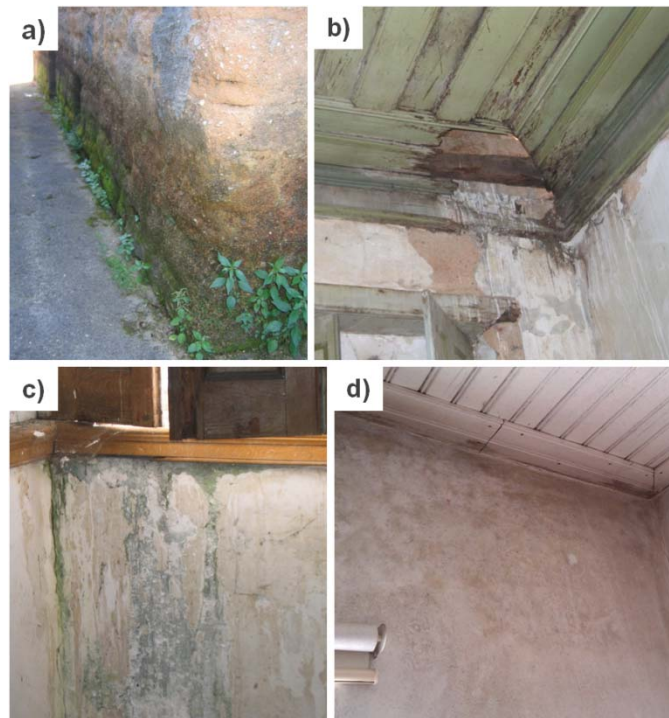
Dampness problems were observed in almost all the buildings studied (Figures 2.11 and 2.19). The different dampness problems identified and their main causes are presented as follows.

Figure 2.19: a) Rising damp; b) dampness at the top of walls; c) water penetration through window openings; d) surface condensation.

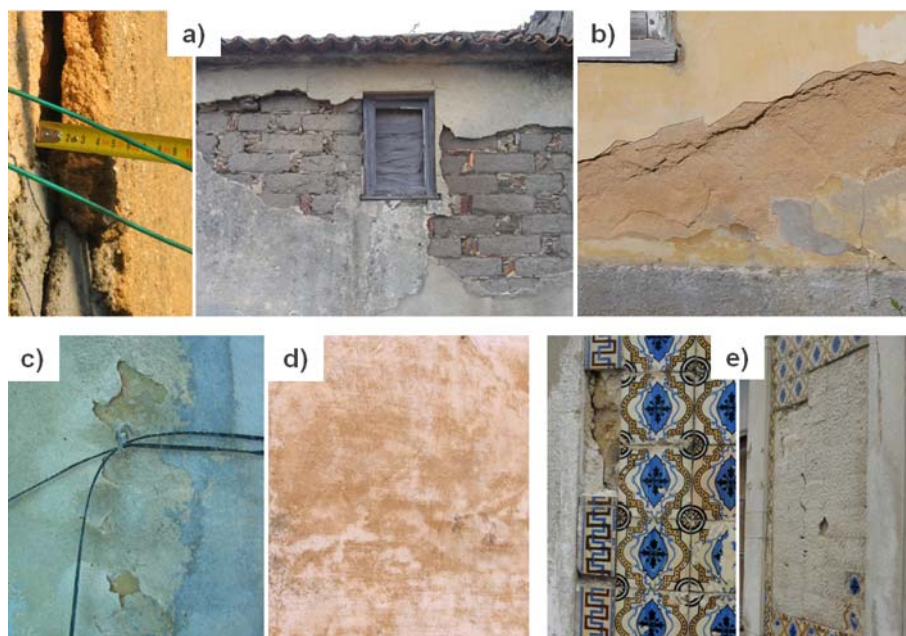
Figure 2.20: a) Render detachment; b) render erosion; c) paint peeling; d) paint erosion; e) ceramic tile deterioration.

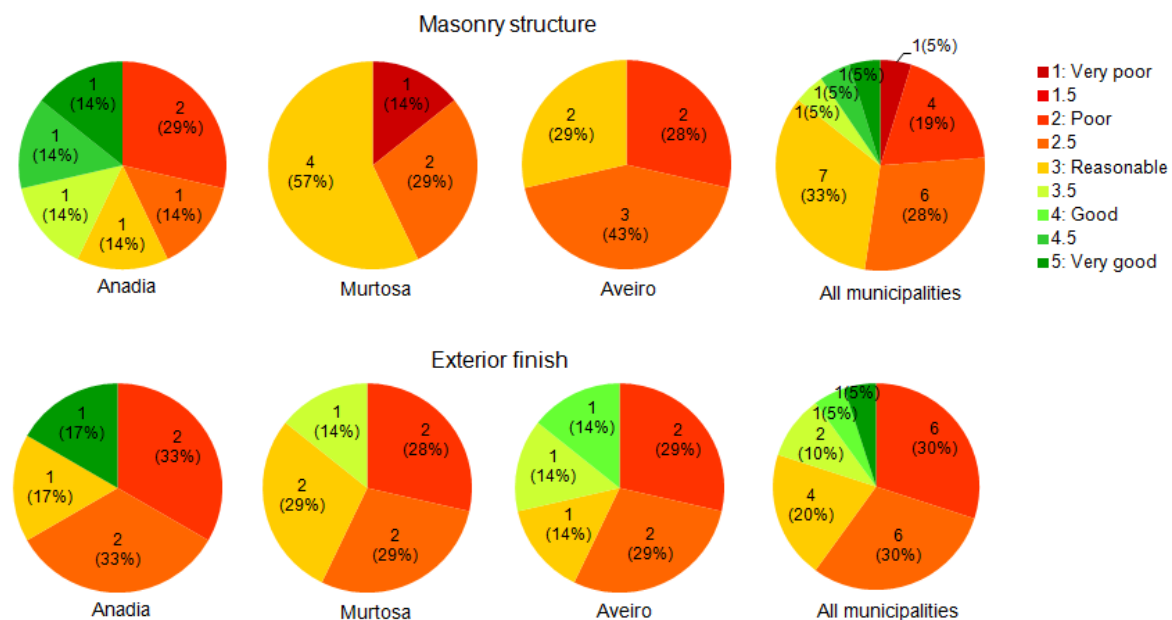
Figure 2.21: State of conservation of facade walls.

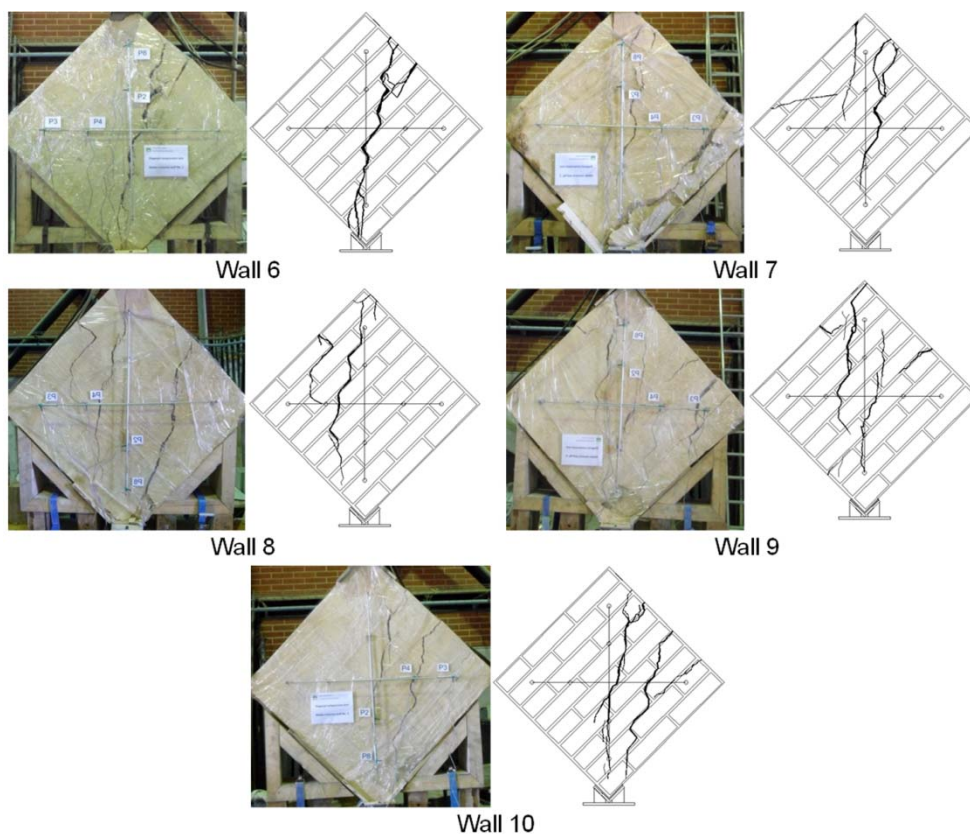
Figure 5.12: Damage pattern on the adobe walls tested in diagonal compression.

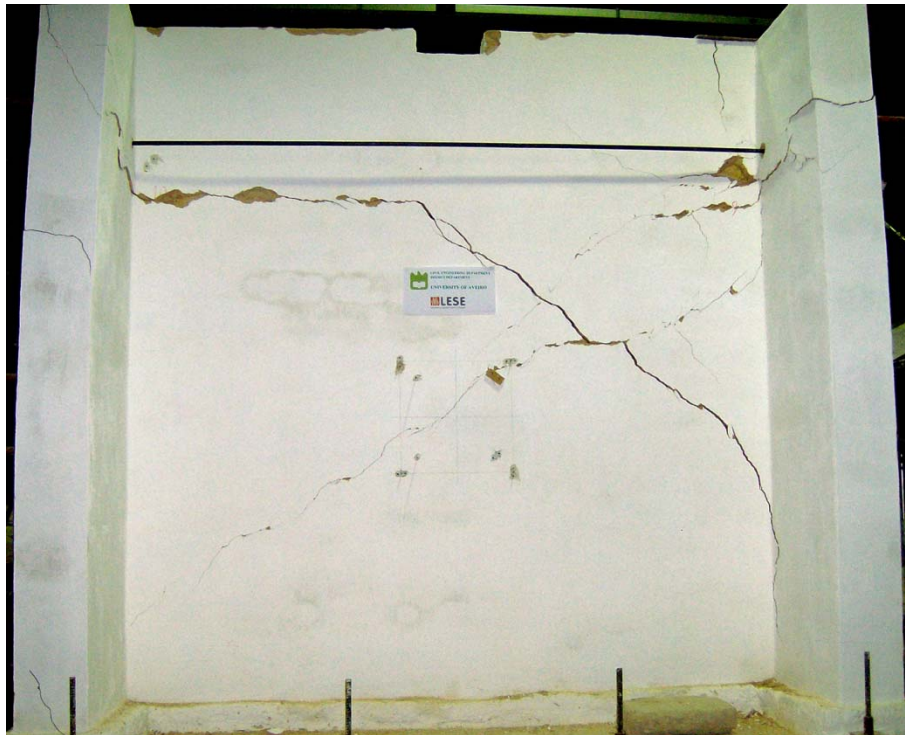
Figure 6.11: Damage suffered by the wall.
